Wee Wah Lake & Pond No. 3  
Dam Rehabilitation Project  
Village of Tuxedo Park, New York

CHA # 30855

June 29, 2018

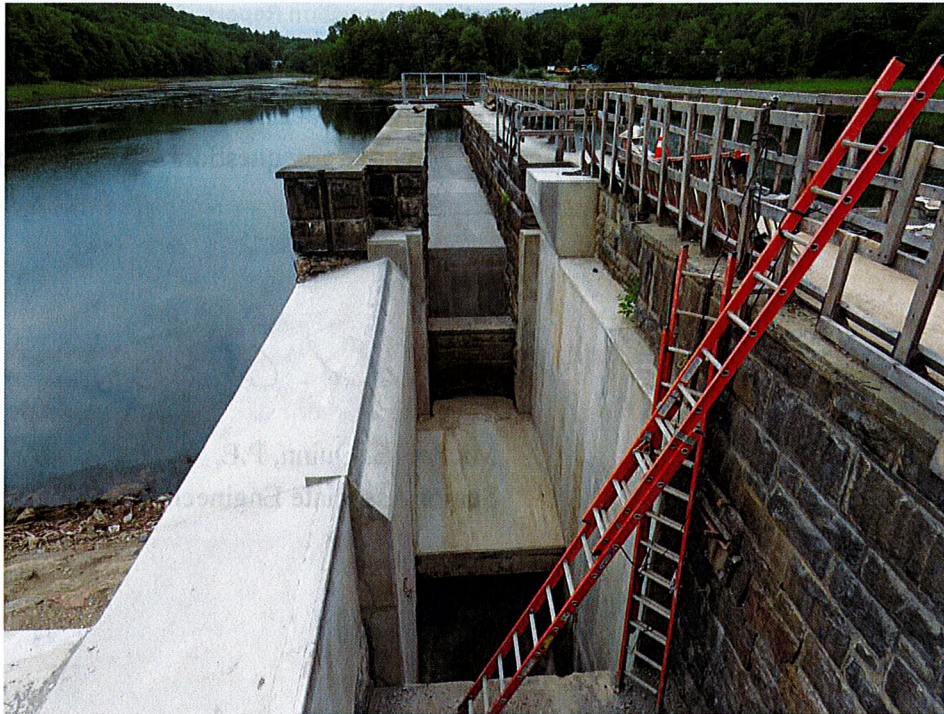
1

Completed construction above the valve chamber.

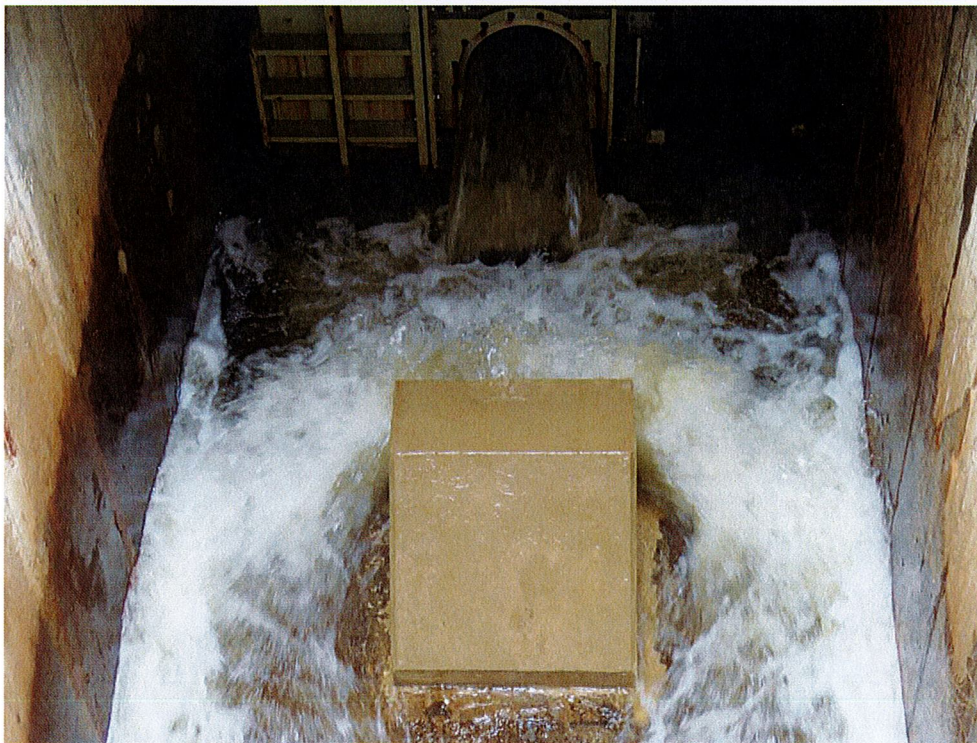
2

Completed valve chamber onstruction. Knife Gate valve in open position during construction pool head.

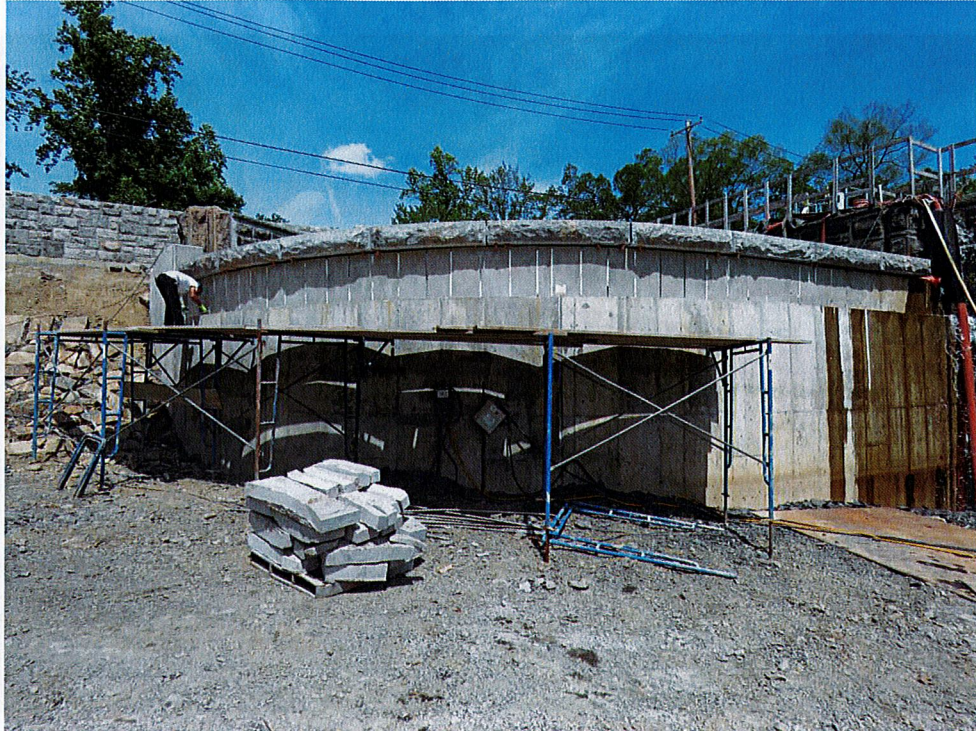
3

Auxiliary spillway structure showing completed capstone placement.

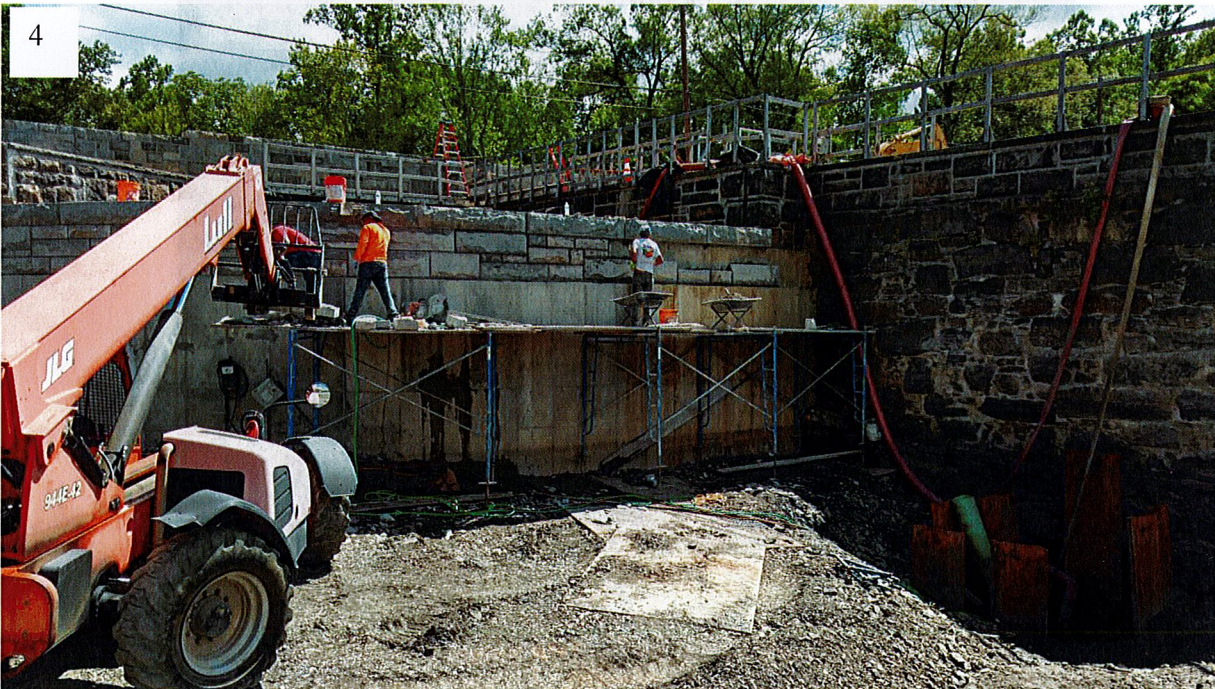
4

Auxiliary spillway granite veneer effacement of collar section of weir.

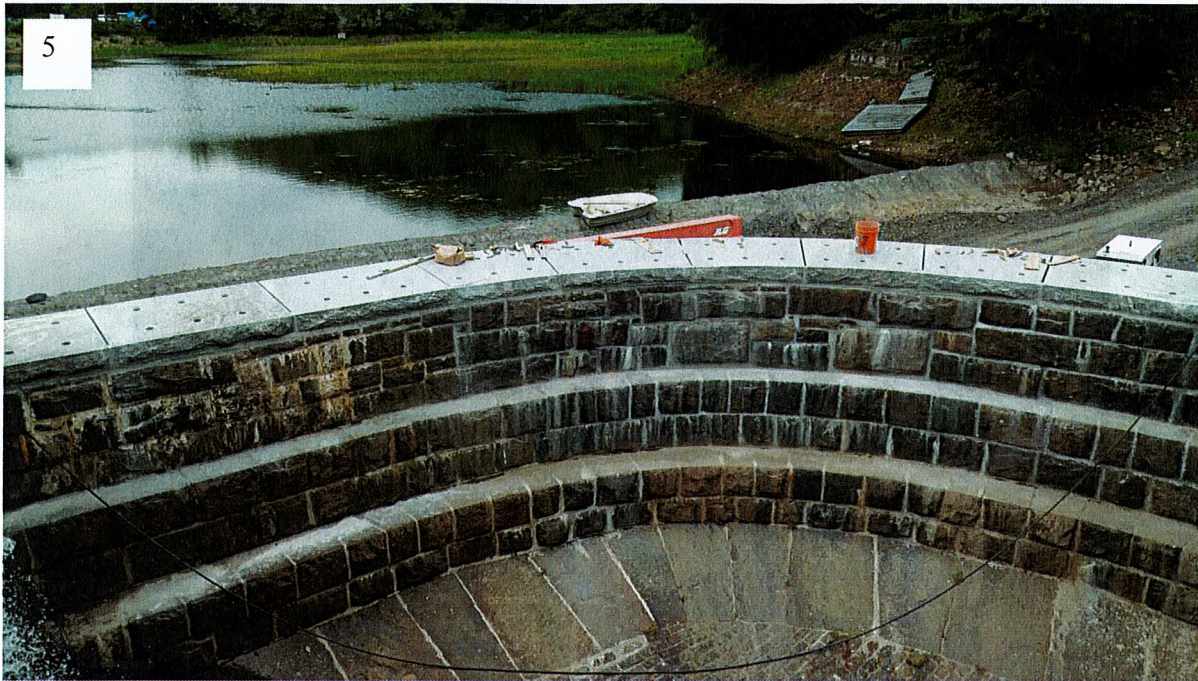
Completed Auxiliary Spillway capstone placement (grouting and anchoring not completed).

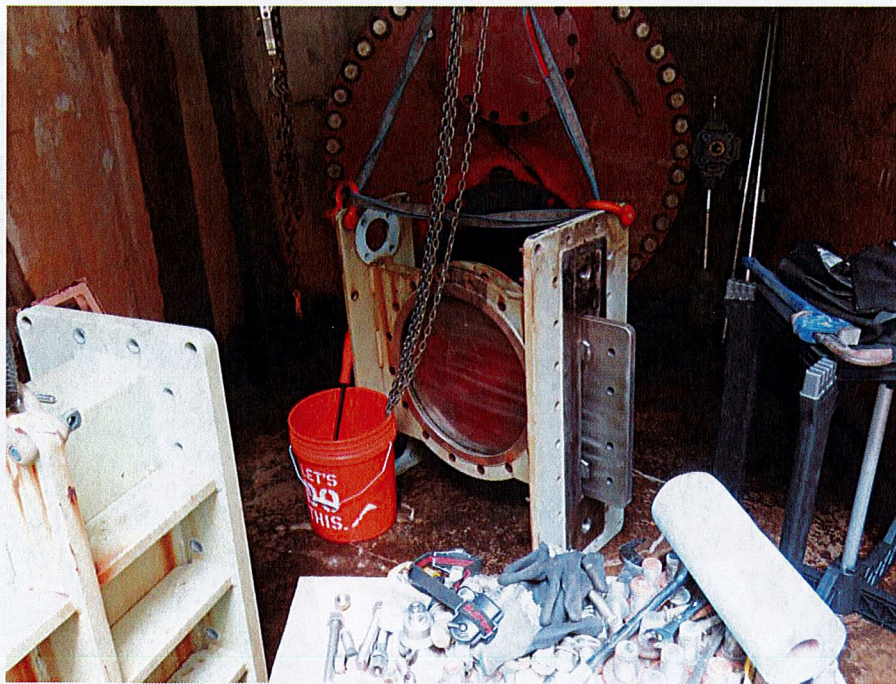
6

LLO knife gate valve correction of gate seating orientation.

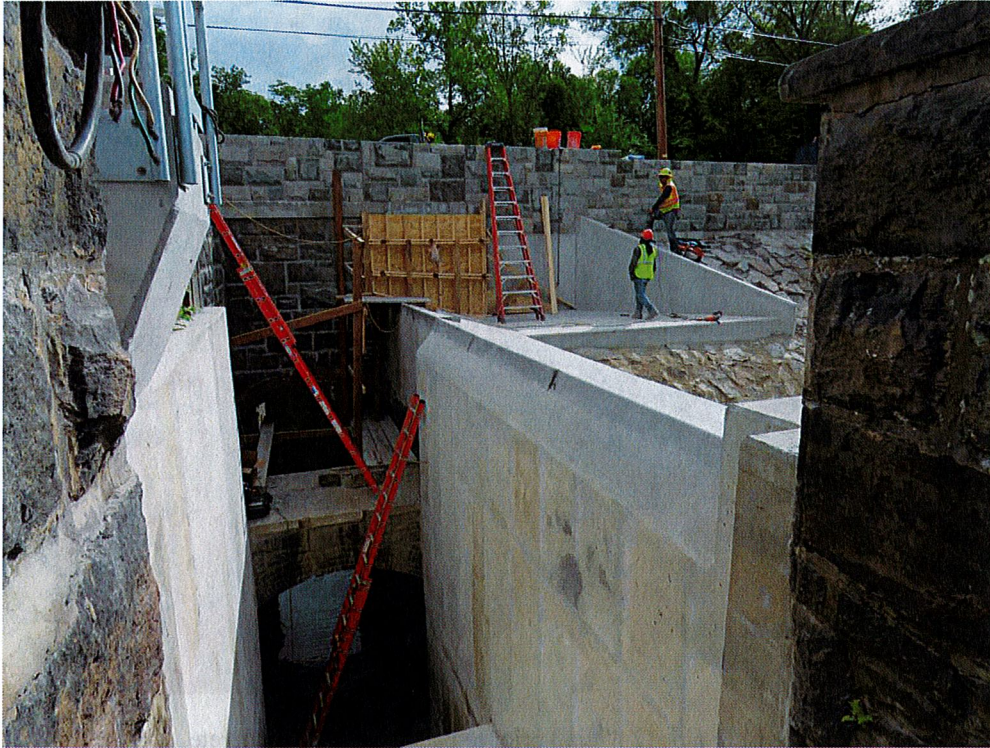
7

Primary spillway forebay showing last segment of overpour construction.

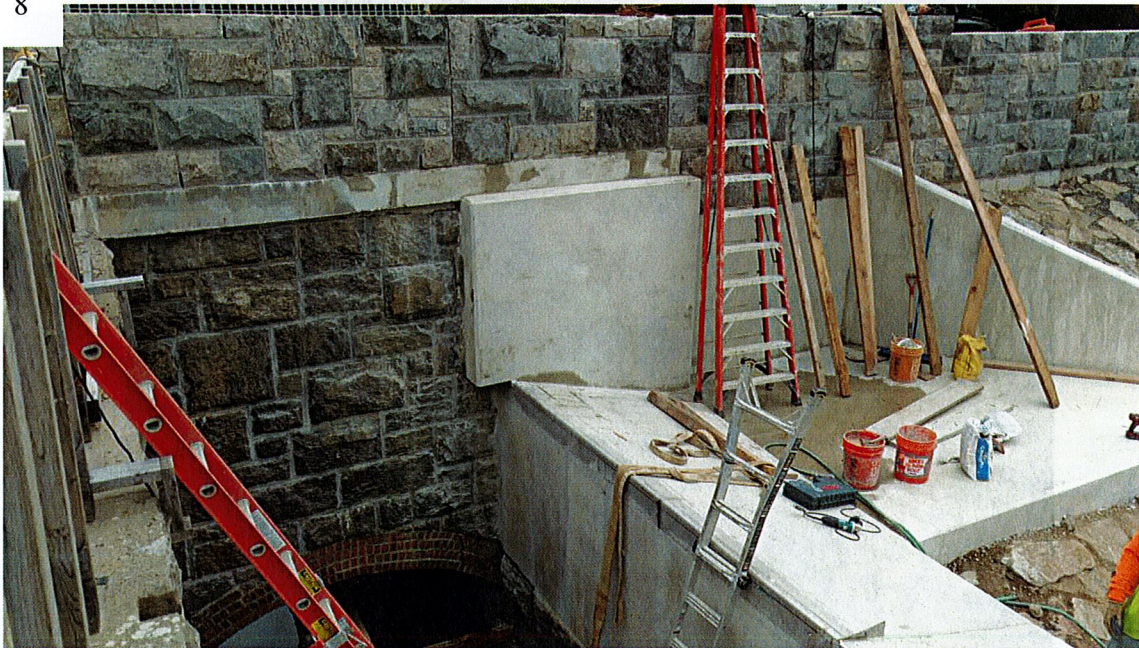
8

Primary spillway forebay structure showing completed concrete construction.

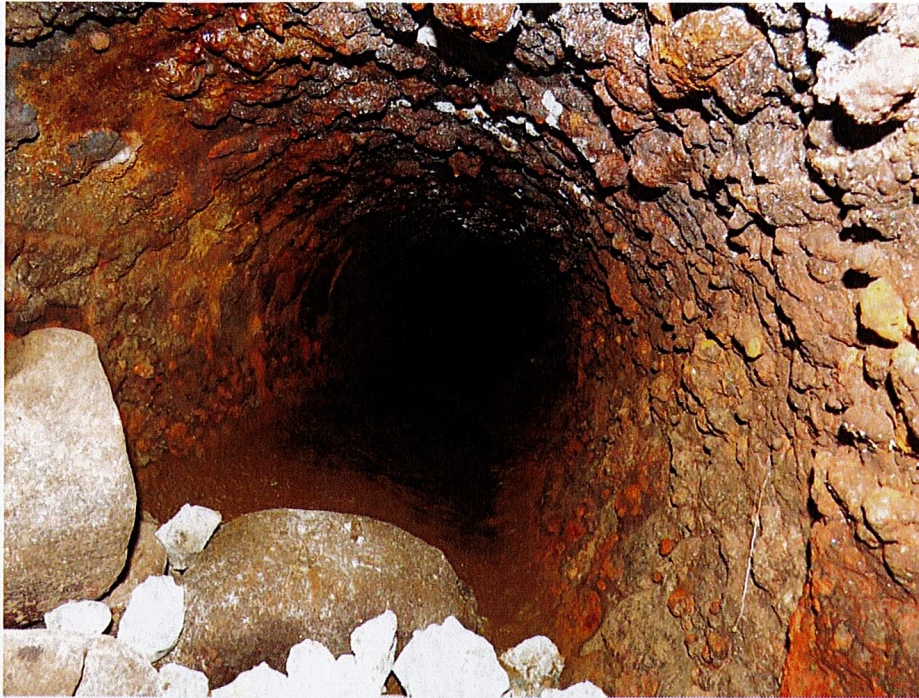
9

Former LLO pipe (24" dia.) prior to backfilling with concrete.

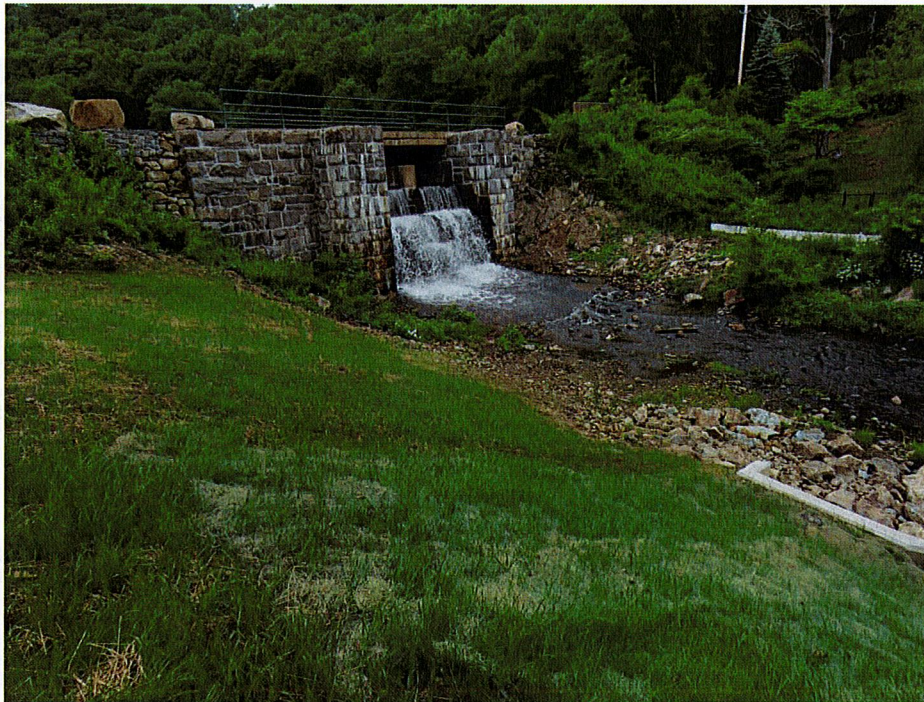
10

Pond No. 3 completed LLO siphon system, old outlet abandonment and repointing.
